## Safety Recall: Automatic Transmission 2nd Gear Inspection

(Supersedes 04-021, *Safety Recall: Automatic Transmission Second Gear Inspection*, dated November 16, 2004)

### BACKGROUND

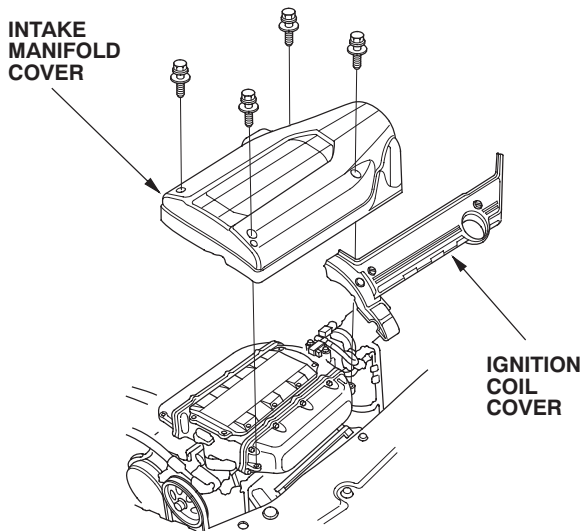
**Odyssey:**

- For a complete description of the inspection procedure, [CLICK HERE](#) for an online animated version.
1. Remove the intake manifold cover and the ignition coil cover.

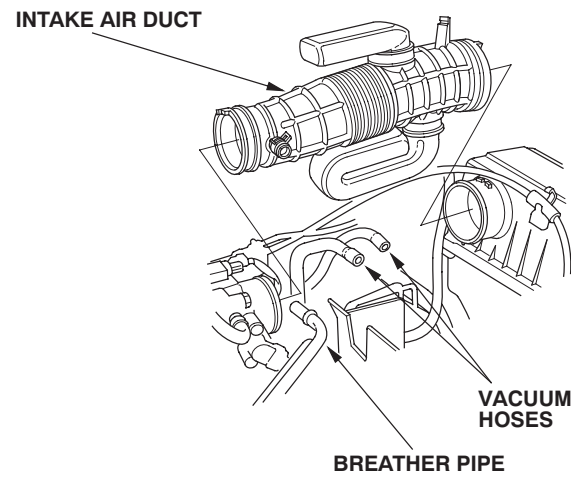
**Odyssey:**

2. Remove the vacuum hoses and the breather pipe, then remove the intake air duct.

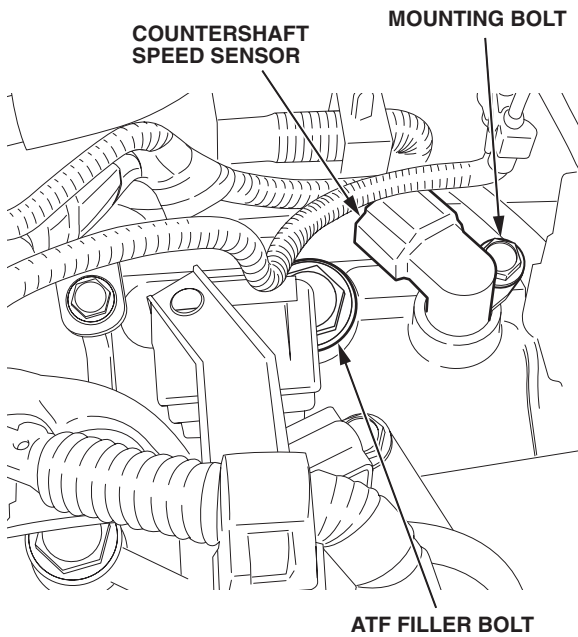
3. Clean the area around the ATF filler bolt, the countershaft speed sensor, and the ATF filter line.

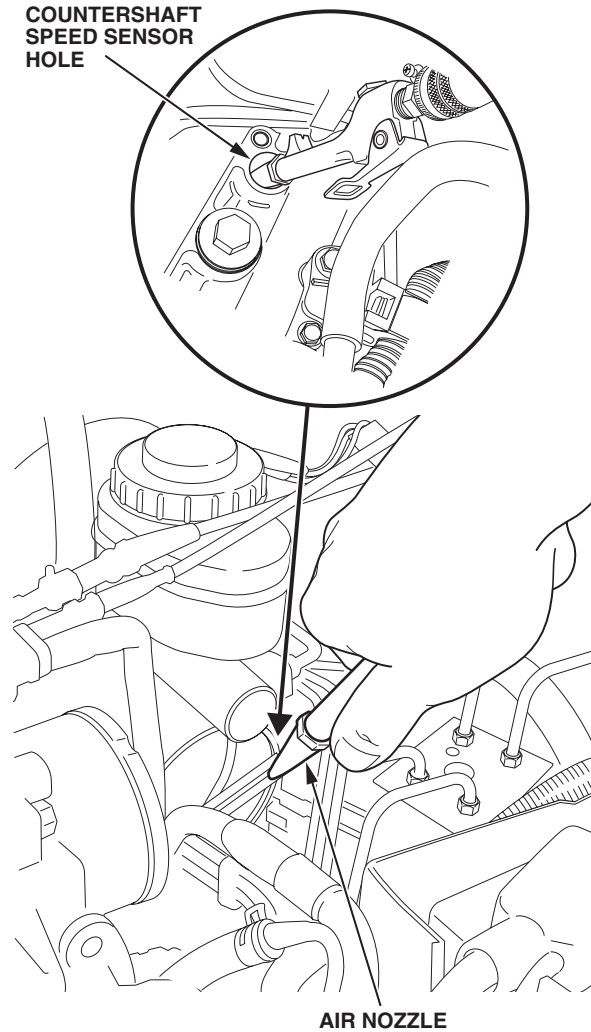
5. Connect an air nozzle to the shop air supply. Insert the nozzle into the countershaft speed sensor hole, and blow air onto the top of 2nd gear for at least **15 seconds**.

NOTE: This step is very important; it removes residual ATF from the gear so you can see it more clearly. Make sure you blow air over the entire top of the gear. Do not use anything but compressed air for this step.

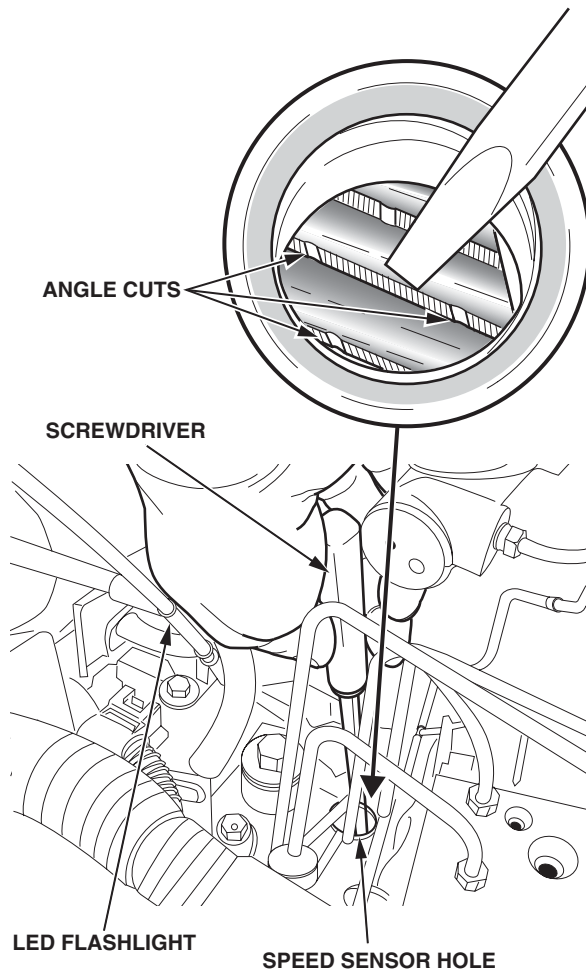
- Point the LED flashlight at the sensor hole to light up 2nd gear. Use a small, flat-tip screwdriver to scrape across the top of the gear teeth. This will help you get a clearer photo of the gear.

- If the gear teeth are brighter where you scraped them, it is a first sign of gear overheating.
- The angle cuts near the top of the gear teeth are not a defect in the gear; they are used to identify gears during A/T assembly.

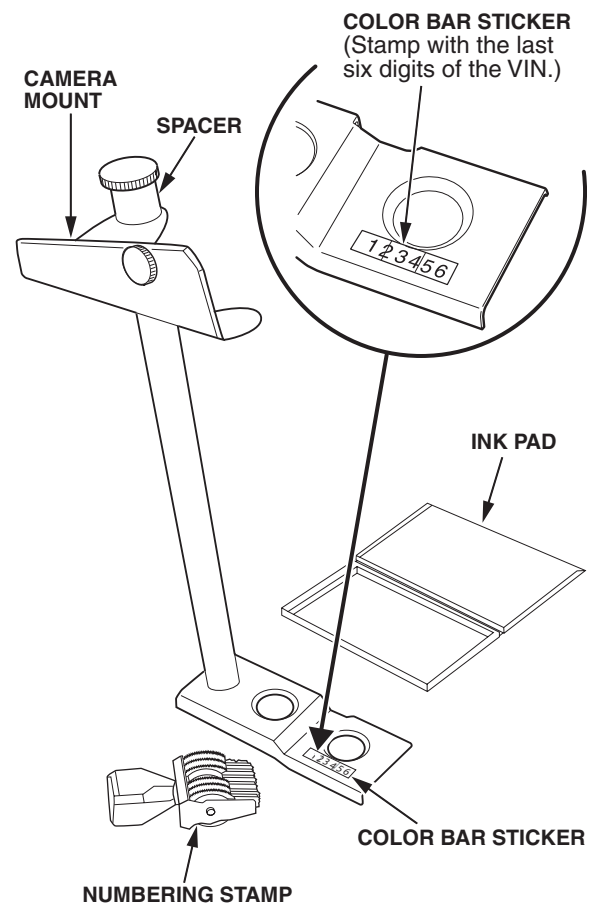
- Apply a color bar sticker on the base of the camera mount. Set the last six digits of the VIN on the numbering stamp, ink the stamp with the stamp pad, and then stamp the VIN onto the color bar sticker.

**NOTE:** For verification purposes, you'll need to use a new color bar sticker and the correct last six digits of the VIN for each vehicle you inspect.

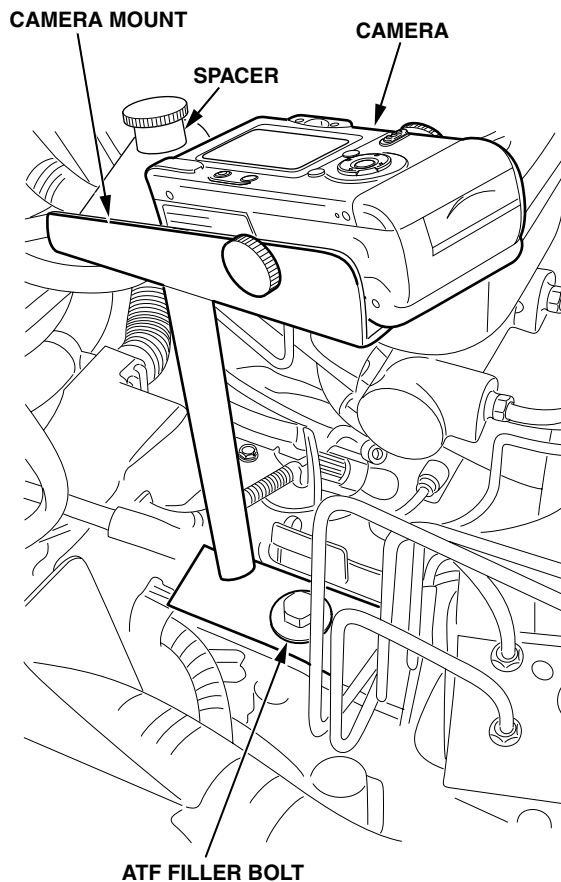
13. Use the ATF filler bolt to attach the camera mount to the A/T.

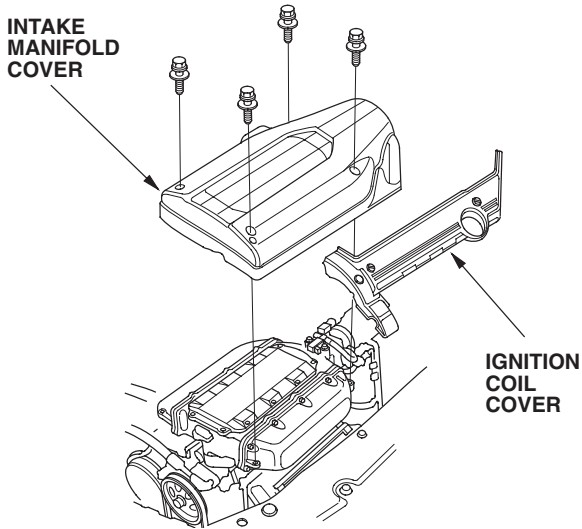
**Odyssey:**

1. Remove the intake manifold cover and the ignition coil cover.

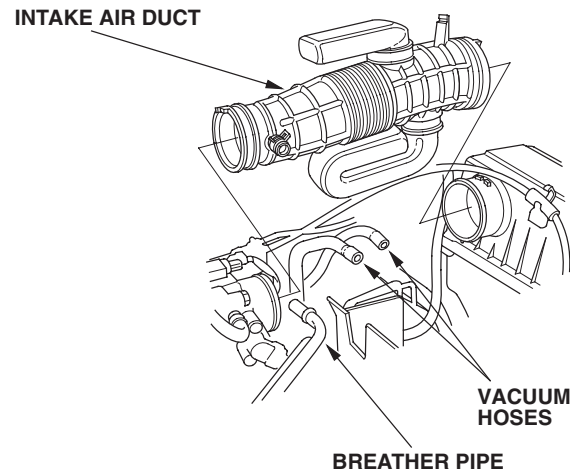
**Odyssey:**

2. Remove the vacuum hoses and the breather pipe, then remove the intake air duct.

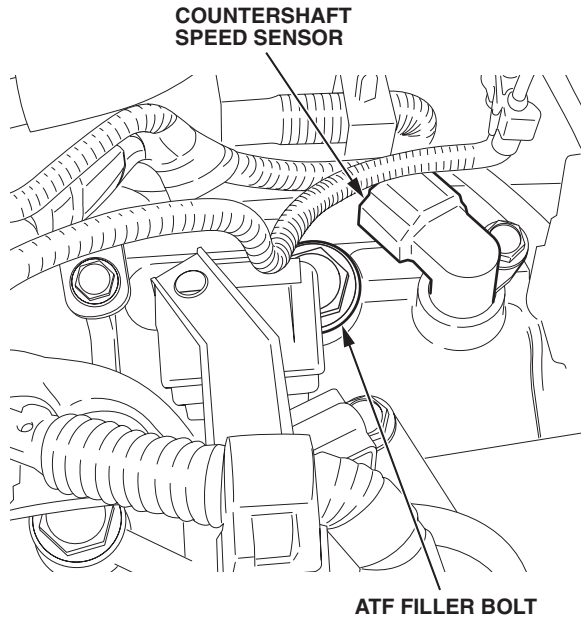
- Clean the top of the A/T around the ATF filler bolt, the countershaft speed sensor, and the ATF filter line.

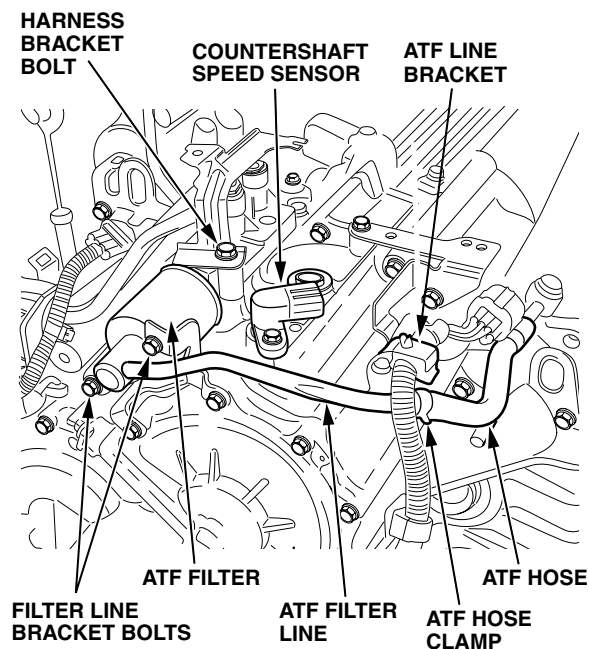
**A/T BEFORE INSTALLATION OF  
A/T OIL JET KIT**

- Odyssey models:* For easier access to the ATF filter line, unplug the ABS modulator connector, and move it out of the way.
- Pilot models:* For easier access to the ATF filter line, unbolt the ABS modulator from its mounting bracket, and move the modulator up slightly.
- Disconnect the ATF hose from the ATF filter line, and discard the hose clamp.

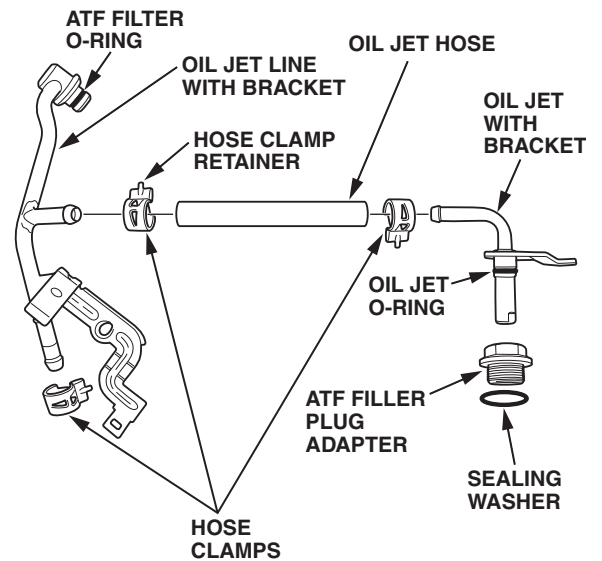
- Detach the wire harness from the ATF filter line bracket.
- Remove the ATF filter line bracket bolts, then remove and discard the ATF filter line.
- Assemble the A/T Oil Jet Kit outside the vehicle, but *do not attach the oil jet to the oil jet hose yet.*

- Each hose clamp has a retainer to hold it in its spread position. To install a hose clamp, slide it into position (**7 mm** from the end of the hose), then pull off the retainer with pliers
- Use clean ATF to assemble all metal-to-rubber lines and hoses. *Do not use grease or any other lubricants.*
- Make sure you slide the oil jet hose onto the T-fitting on the oil jet line.

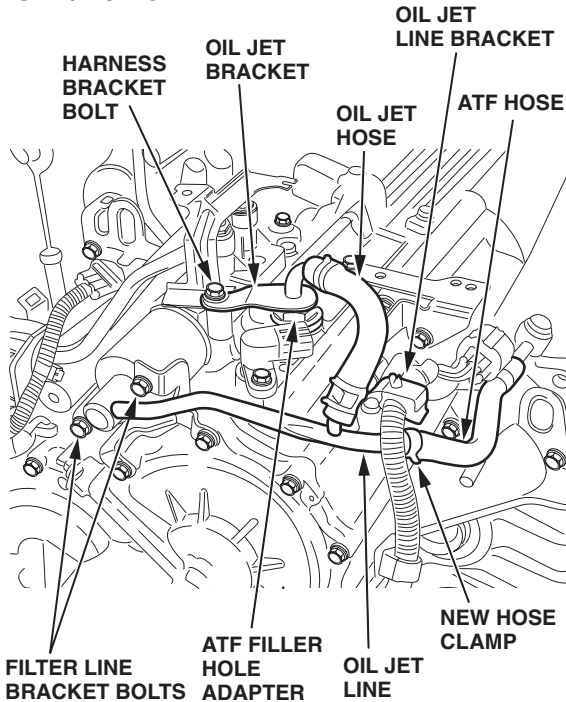
**A/T AFTER INSTALLATION  
OF A/T OIL JET KIT**

10. Install the oil jet line onto the ATF hose with a new hose clamp.

- Use clean ATF to lubricate the oil jet O-ring and the ATF filter O-ring before installation.
- Make sure there are no kinks in the oil jet hose when you install it onto the A/T.

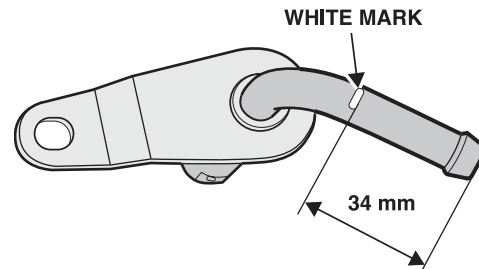
16. Check if the oil jet has a white mark **34 mm** from the end of the pipe. If it does not have this mark, measure **34 mm** from the end of the pipe, and use a paint pen or marker to mark the spot.

17. Slide the new hose clamp onto the oil jet hose, and then slide the oil jet hose onto the oil jet tube up to the mark on the tube. Make sure the hose is not kinked. Position the clamp **7 mm** from the end of the hose, and release the clamp retainer.
